The Analysis Correlation of Tool Wear with Signal Frequency Domain During ST 60 Milling Process Using the Pearson Correlation Coefficient Method

Elvis Adril^{1*}, Asmed¹, Yuliarman¹, Maheka Restu Araliz¹, Afif Elqudsi¹

¹Politeknik Negeri Padang, Padang, 25164, West Sumatera, Indonesia.

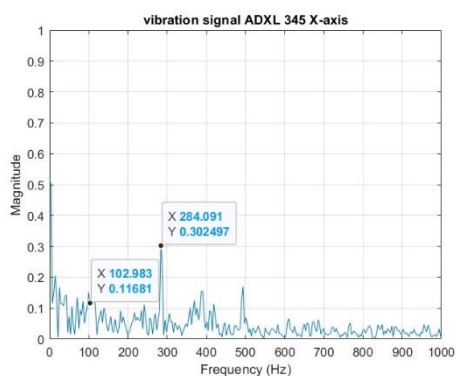
Figure 1: 1st Vibration Signal On X-Axis

The dominant frequency detected in the 1st experiment was 284.091 Hz (Figure 4). This was not the cutting frequency, and it was identified as an unknown frequency. Meanwhile, in the 100th experiment, it was found that the dominant frequency detected was 287.53 (Figure 5), with different amplitudes. This amplitude difference phenomenon indicated that the cutting tool used has experienced wear and tear (Ahmad et al., 2015). A frequency signal of 387.409 Hz (Figure 6) generated by the Y axis was detected at the beginning of the experiment while in the 100th experiment, the detected frequency was nearly two times the IPF of 102 Hz, which is the cutting frequency. However, the detected frequency was 108.959 Hz (Figure 7).

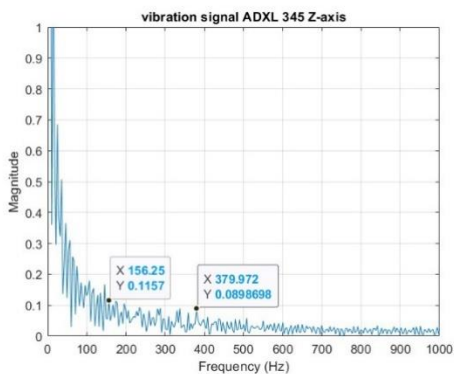
Figure 5: 1st Vibration Signal on Z-Axis

On the Z axis, the frequency signal detected showed the cutting frequency (Figure 8) but at the 100th signal, the frequency observed at the beginning was no longer present (Figure 9), there was only a decrease in the amplitude of the dominant signal detected by the accelerometer sensor.

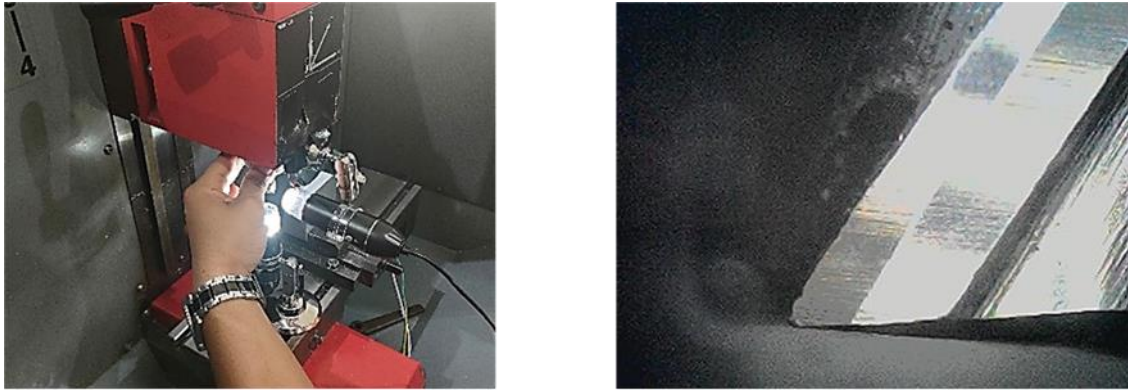
Figure 10: a) The position of the digital microscope during the capture of the tool (left), b) Result of capture

This research used a 10mm End Mill to cut AISI 1050 or ST 60 workpiece. As the cutting session or experiment progresses, the cutting tool used will experience increasing wear. This research clarified and identified the type of wear that occurred on the cutting tool during the milling process of an AISI 1050 workpiece using a digital microscope.

Figure 10 a) shows that the cutting tool used still looks sharp and new. Figure b) shows that the cutting tool has experienced normal wear, which can still be considered stable and this condition was found in the 28th experiment. Figure 10 c) shows the condition of the cutting tool which has experienced heavy wear, which was predicted to occur in the 55th experiment.

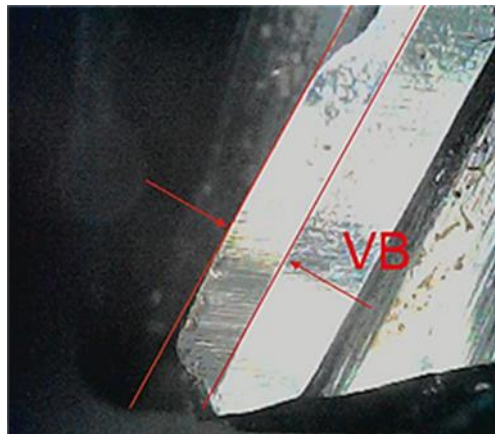
Figure 12: Measurements to determine the wear value

In the results of wear measurement with a digital microscope, the wear on the cutter was identified as edge wear, also known as Flank Wear (VB), as shown in Figure 12.

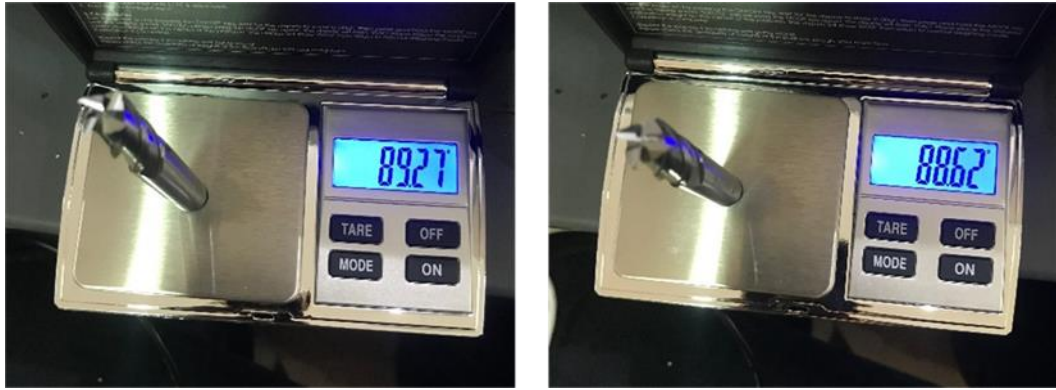
Figure 17: a) Initial Cutter Weight before 1st Cutting Process, b) Cutter Weight after Cutting Process (100th)

Figure 17 shows that before the experiment, the weight of the cutter was 89.27 g and at the end of the experiment, the weight of the cutter was 88.62 g. So, the total weight loss of the cutter during the cutting process, which resulted in wear was 0.646g.

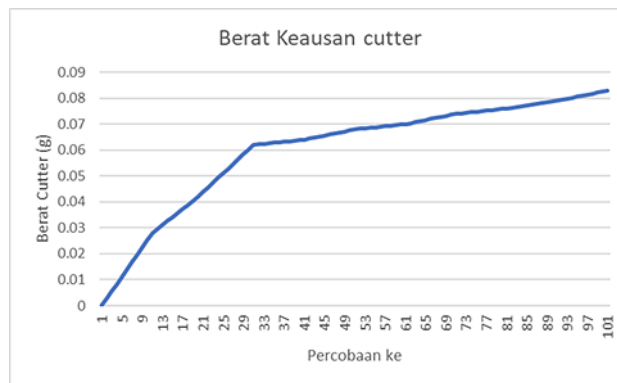
Figure 18: Cutter weight loss due to wear

In Figure 18, the progression of wear values from the beginning to the end of the experiment is shown.
